FACILITY COMPLIANCE AUDIT REPORT

Date of Audit: April 11, 2011

Johnston County MSWLF, Closed MSWLF and CDLF
680 County Home Road
Smithfield, NC 27577

Partial audit of a MSWLF and CDLF

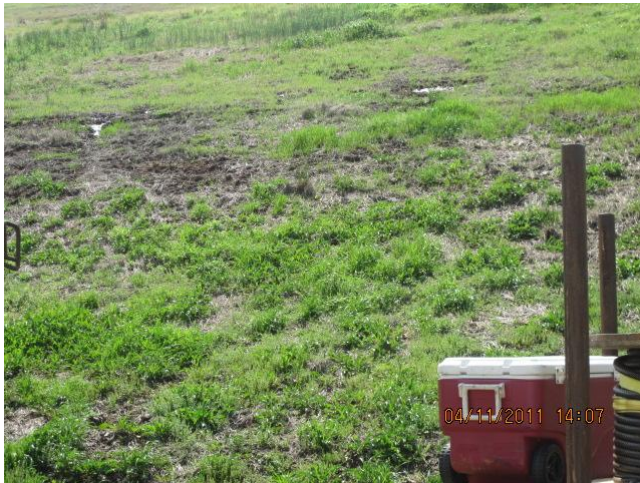
4. There are quite a few seeps on the side slopes including Cell 5. **Areas that are weeping need to be monitored and additional cover placed over the areas to prevent leachate from flowing outside the edge of waste.**

Seeps on the east side of Cell 5

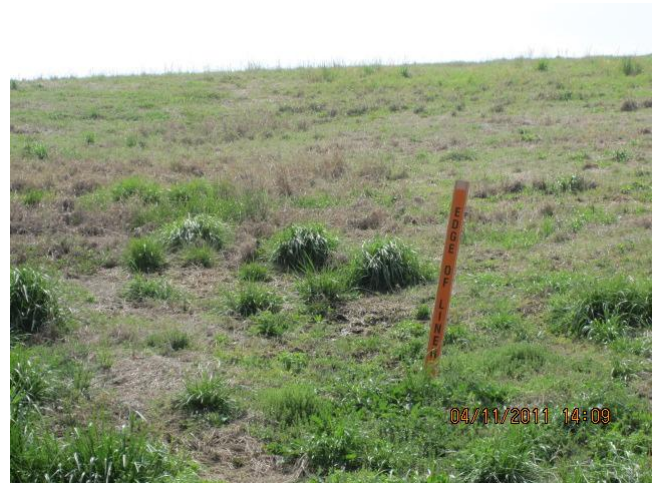
Seep near Edge of Liner marker, Cell 5

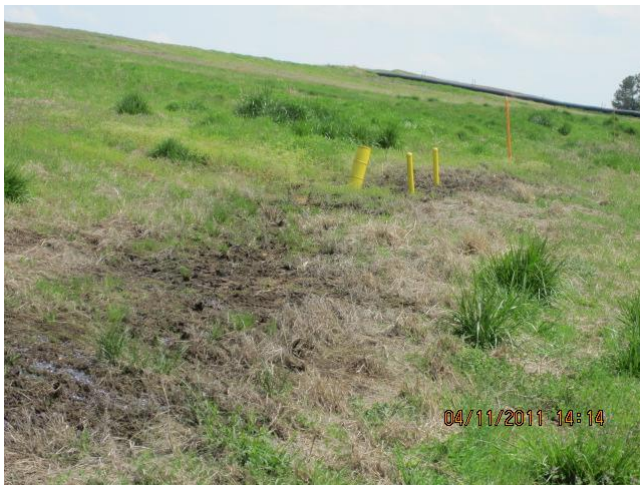
More seeps Cell 5

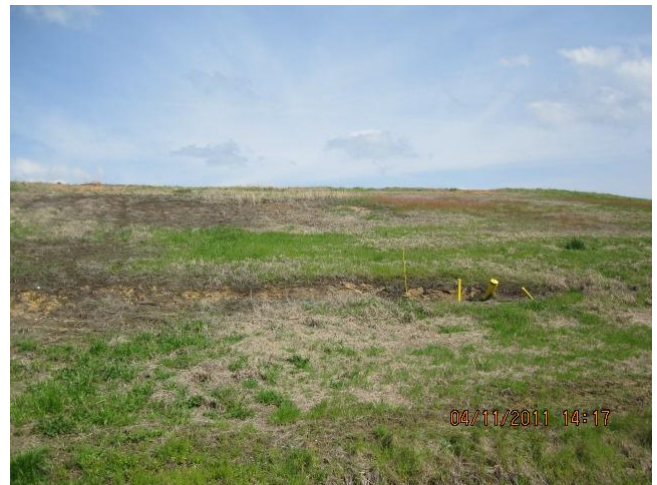
5. There are several bare areas on side slopes including Cell 5. **The provisions for a ground cover sufficient to restrain erosion needs to be provided within 30 days.** I would recommend taking advantage of the spring planting period.

Bare areas that have slight erosion and needing ground cover established

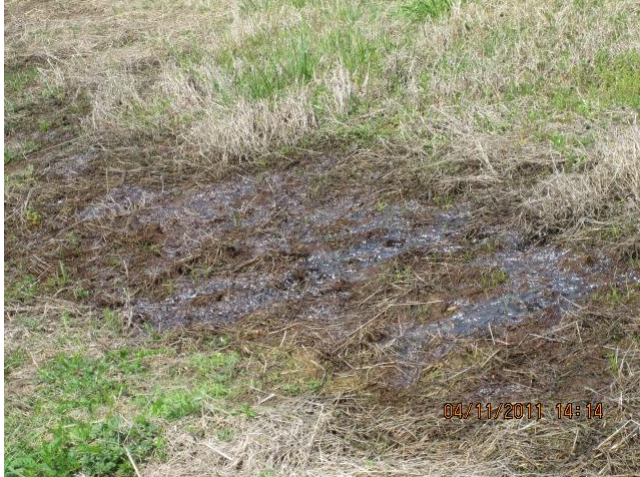
Seep

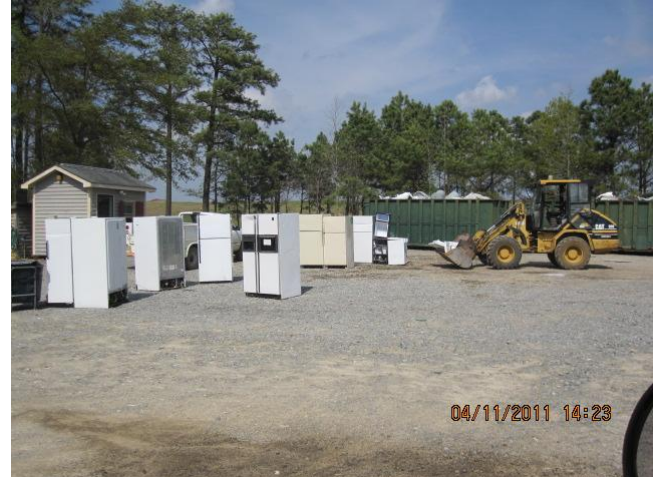
15. Batteries are collected and kept on pallets at the tire area.
16. The white goods area was very clean and CFC removal appears to be kept up to date.

Well maintained white goods area

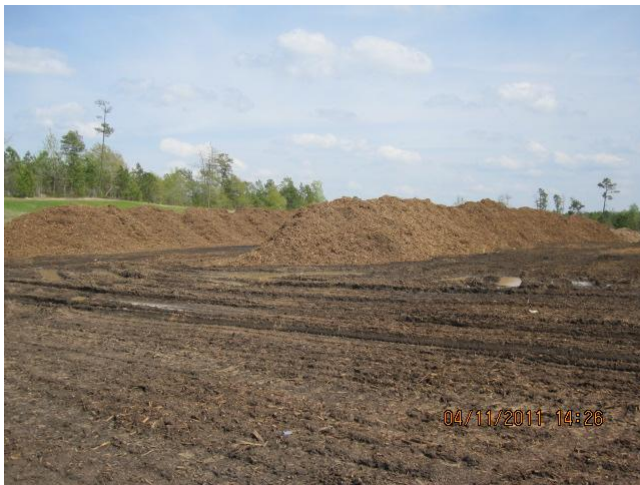
13. The Yard Waste area is being managed well at this time.
14. The scrap tires are kept in covered trailers and are being managed properly at this time.

Windrows of ground material at yard waste area

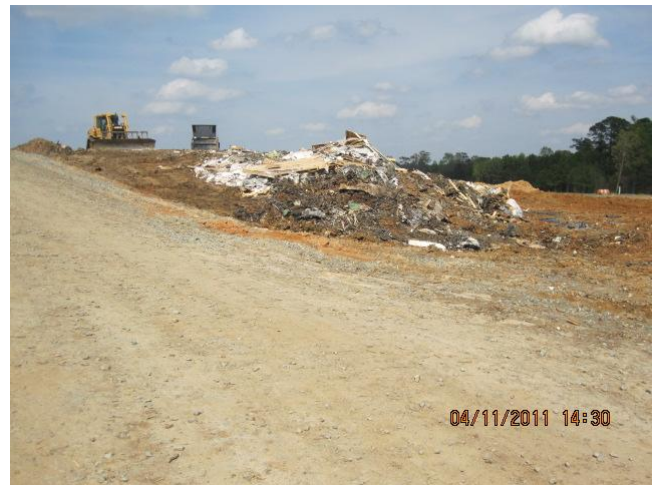
1. The working faces at the C&D and the MSW landfills were kept small and appeared to be well compacted.
2. **Cover is needed in several areas at both the C&D and the MSW landfills to prevent the exposure of waste.** This has been commented on in the previous audit. The waste must be covered with a minimum of six inches of soil and maintained until final cover is provided.

Well compacted and small working face at C&DLF

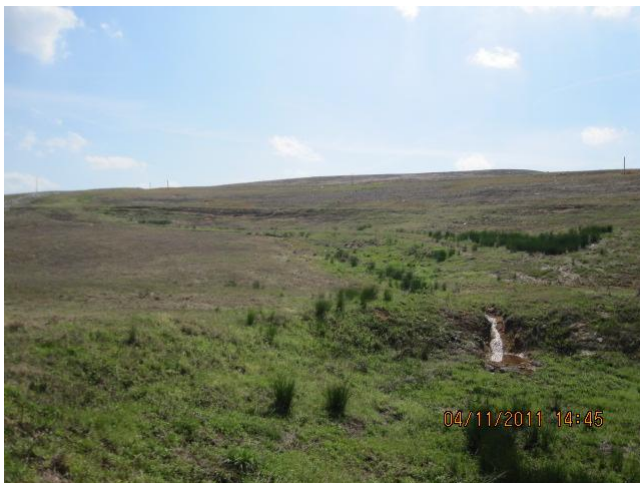
7. There are some minor areas of erosion that need to be repaired on some of the perimeter side slopes. I would recommend repair and seeding these areas as they are noticed to prevent further erosion.

Water causing erosion on the north side of MSWLF,
Heading into sediment basin across access road

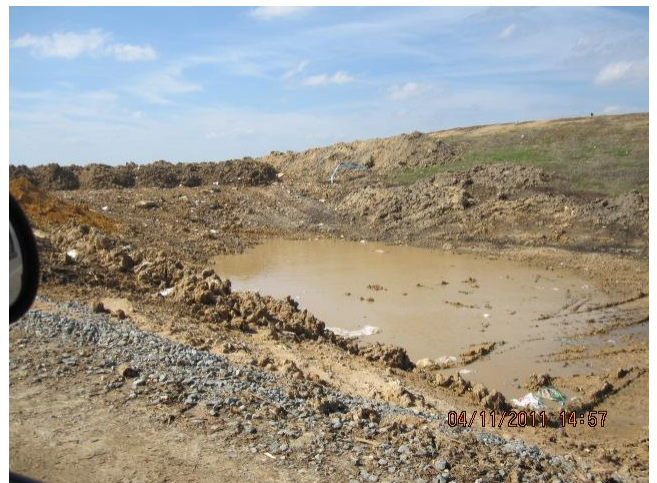
3. There was ponding water over waste to the right of the access road to the working face at the MSWLF. There was also ponding water further back to the right of the working face. Ponding areas need to be re-graded and provided with positive drainage to eliminate this from occurring.

Surface water impounded over waste on right side of
approach road to MSWLF working face

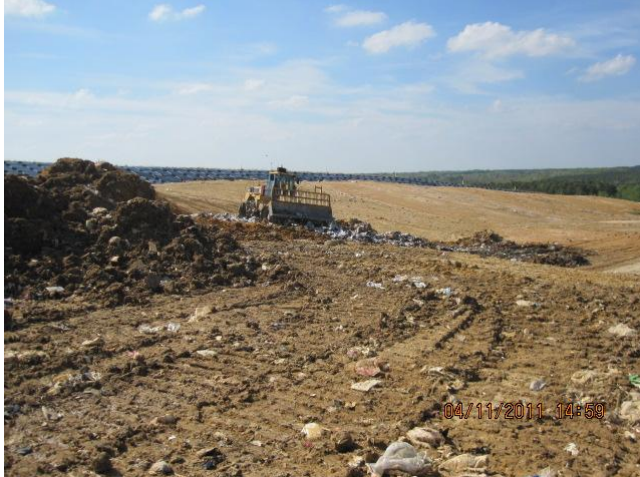
Exposed waste before getting to MSW working face

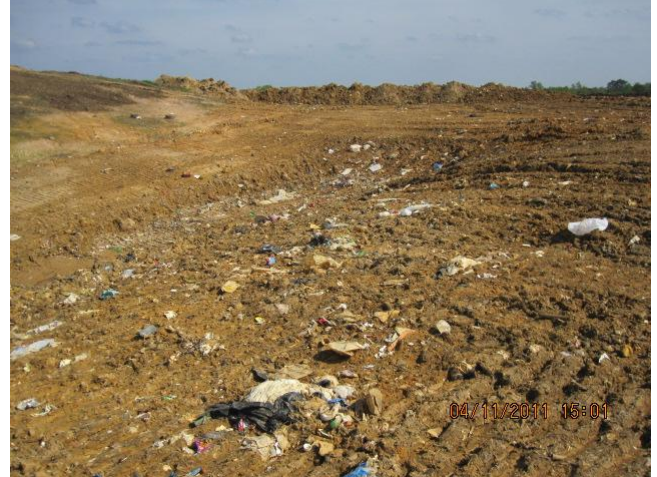
More exposed waste at MSWLF
